The Electricity Systems Inspection Case Study for Electrical Substations in Thailand

Surin Charoenchit^{1,*} and Chaiyapon Thongchaisuratkrul¹

ABSTRACT

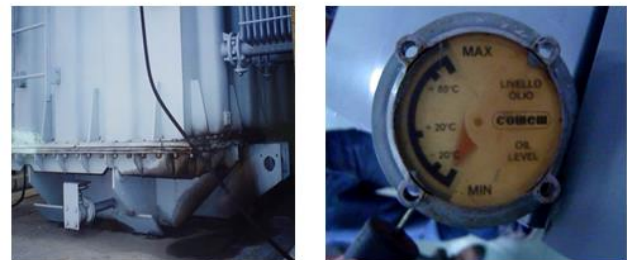
Because cost of new transformer is large more expensive than maintenance cost, the problem should be solved instantaneously. In the case of oil level gauge defective, generally the gauge is defective by life time. The

gauge is important for routine checking. It should be calibrated for measuring precisely. If this gauge defective, the value of oil level is not the right check. Therefore the oil may be leakage, and then the insulation and heat transfer are not enough. This case probably breakdown and over heat in transformer. In the case of phase protection and control set damage is found the less. However, it is the most important because it protects the loss and damage in the case of emergency or accident. If the protection and control is not run in the case of faults, not only transformer is damaged but other equipment also.

(a) Oil Leakage (b) Oil Level Gauge Defective

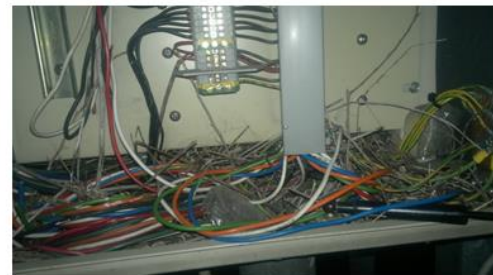
(c) Control Set Damage

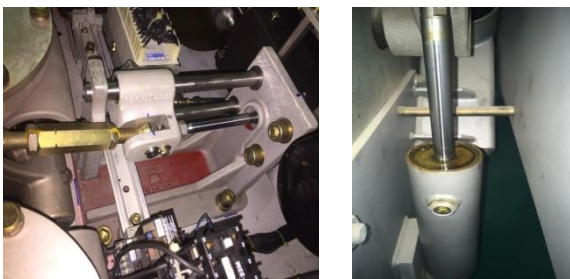
In this section the deteriorations in switch gear of four electrical substations are inspected. Although they are done routine maintenance, they are still found deteriorations including high humidity in SF₆, hydraulic pump leakage, damper seal CB leakage and finally counter damage. The inspection of four electrical substations in switch gear is shown in Fig. 8. It is found that the most found deterioration switch gears are high humidity of SF₆ about 50%. The second deterioration is hydraulic pump leakage at about 25%. The next is CB damper seal leakage approximately 15%. Finally, counter damage is the last about 10%. By the way SF₆ insulation gas, it is used to quench the arc in circuit breaker of switch gear. If the gas is high humidity, the SF₆ gas insulator is low characteristic of insulation and arc quenching. Therefore, in the case of open or close circuit by breaker, the arc occur high harsh arc. These effects on the fire or blast in switch gear. This brings the breakdown in system and damage in equipment. Moreover this probably brings blackout around the area. For hydraulic pump, it is used to be force for drive breaker

open/close circuit. The force is occurred by oil pressure. Therefore, in the case of leakage, the force is less depending on the oil, then it cannot drive breaker. This is problem because the electrical system is not close and open anytime it needed. It should be changed immediately. For CB (Circuit Breaker) damper leakage, it occurs from oil is leakage so the pressure to force breaker close/open is less. While the force of hydraulic sends to breaker, the leakage CB damper is not send the force to close or open circuit. The CB is harsh vibrated. This CB is damaged. The hydraulic and CB damper leakage are shown in Fig. 9. In the case of counter, it is used to count the number of close and open circuit breaker. Generally, the breaker should not often open and close because the arc would damage it. So, the number of close and open is limited for maintenance. If the counter damage, it is not sure the time to maintenance.

(a) Hydraulic pump leakage (b) CB damper leakage

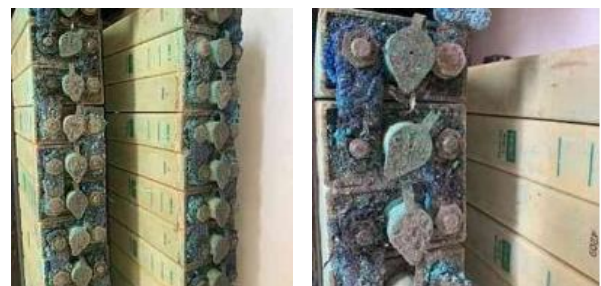
storage in the case of power outages. The conserved energy is important on stability of system especially emergency case. When they are not used in the long time, they may be neglected to maintenance. From inspection, it found that the oxide occur on terminal as shown in Fig. 11. This problem causes on the efficiency directly of battery. The oxide effect on conductance condition of connector is lower. So the current distribute is low also. If they are neglected, battery life time is shorter than it should be. They should be clean in routine. The capacity of battery reduces because of lake of maintenance and maybe it occurs by life time. Generally, battery life time is about 3-6 years. Battery should be not used still loss out energy storage. This causes on life time also. The terminals of battery are cleaned in the routine. The place of installation should be dry which avoid high humidity.

Fig. 11. Oxide on junction of Battery Backup.
