# Local Flood Risk and Responding Adaptation in Northern Bangkok Metropolitan Region: Case of Tha Khlong Municipality

Manatsavee Euanontat<sup>1</sup>, Vilas Nitivattananon<sup>1,\*</sup>, Napassorn Sutthiprapa<sup>1</sup>,  
Thanakom Wongboontham<sup>1</sup>, and Shenghui Cui<sup>2,3</sup>

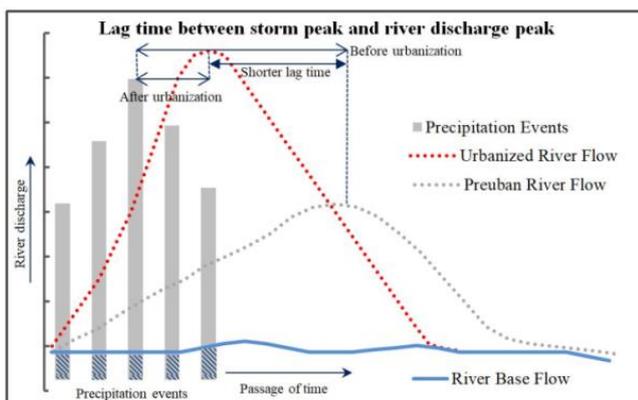
Fig. 1: Hydrological impact of urbanization on the flow of rivers through landscapes (adopted from [8] [10]).

Stormwater floods triggered by extreme rainfall have increased. A study [8] on floods in China has shown that pluvial floods in China caused by extreme rainfall and clouds have erupted in 6 events over the last 10 years. The report [13] claimed that the cause of the floods was climate change, extensive and rapid urbanization, and unsustainable urban development combined with management failure (Fig. 1). In accordance with another study [2], pluvial floods have been correlated with rapid developments, increasing vulnerability to increasing flood hazards due to climate change. In addition to the development dominated by economic growth and lack of environmental aspects, the aquatic ecosystem has been replaced by impervious surfaces at a rate of 6.5 percent per year. This leads to a lack of water resilience and reduces the land capacity to absorb, store, infiltrate, and detain rainwater. On the other hand, soil pollution, frequency, and flood intensity increased. Urban drainage systems that have not maintained pace with developments have resulted in insufficient or poorly maintained drainage capacity.

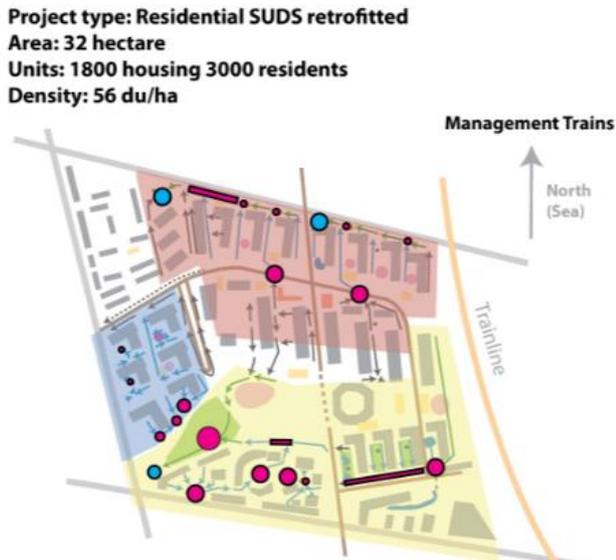
Fig. 2: SUDS implementation at Augustenborg, Malmö, Sweden [16].

In order to enhance drainage functionality and public space, numerous programs control water flow and applied water management techniques. As a result, the drainage was separated into three sections, and the numbers of water collections was used to improve the estate landscape. Any drainage was to be deposited in the local reservoir, while the minimum amount of runoff was drained into the public sewage when the site retention was overflowing. Fig.2

demonstrates the implementation of the SUDS that the design has been observed and noted in order to ensure its implementation. The drainage system was incorporated into the public space design and used as a soft scape feature and visually improve public space as shown in Fig. 3.

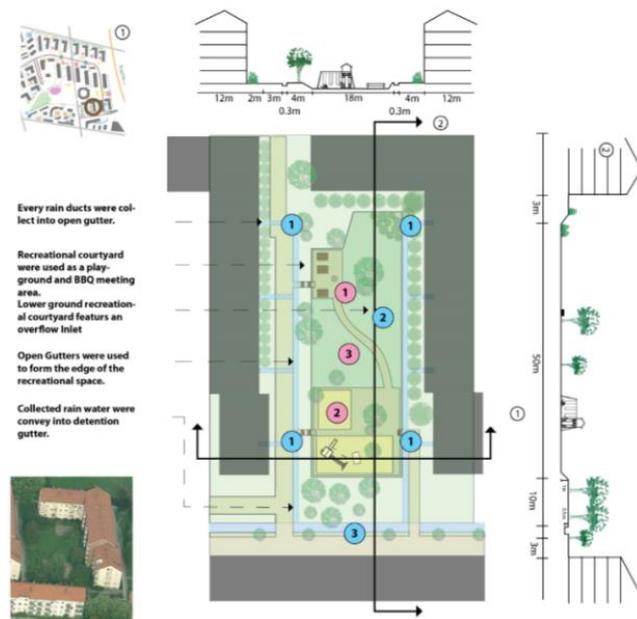
Fig. 3: Example of public space and drainage design [14]

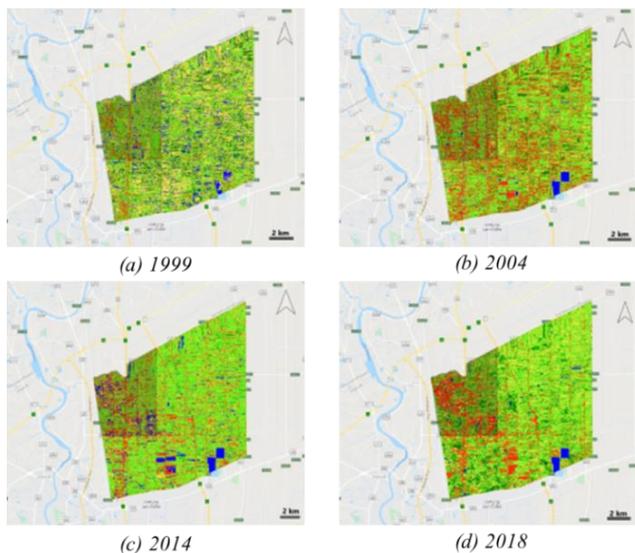
**Fig. 5: Land use changes in Tha Khlong Municipality [21].**

Result of TKM land use land cover analysis in 1999 to 2018 [21] with five-time intervals every five years without 2009 using random forest classification method is shown in Fig.5, with a significant increase in urbanization trends since 2004. The urbanization areas are almost along Paholyothin Road, especially in municipalities of Tha Khlong and Rangsit.

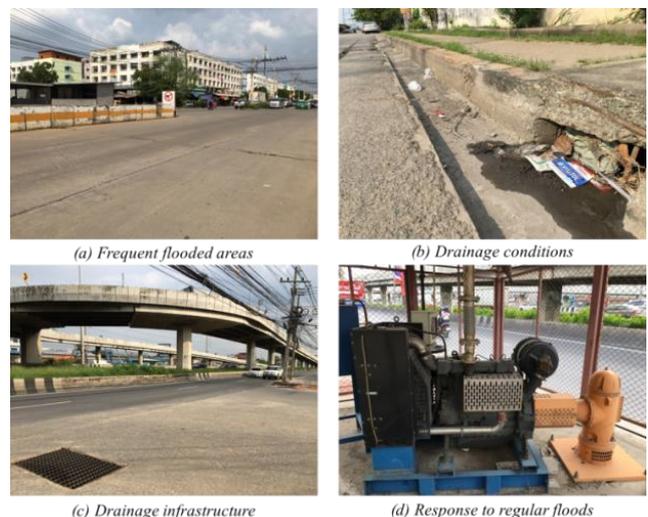
From the survey, as also shown in Fig 6, Km.44 street where the frequent flood has been reported appear to be neglected and the drainages appear to be in lack of maintenance. There are underpass drainage and permanent flood pump which show the government effort to mitigate the flood from the estate. However, the main cause of the Km.44 flood remains and the pump has been deactivated from the community. The equipment management, reportedly, has to be authorized from the Department of Rural Roads. Hence, the equipment cannot be operated by local authority which has to use portable pump. The situation has been shown that the installation of the device was not enough to solve the problem.

**Fig. 6: Photos taken from field survey, 2019.**

According to the survey, the drainage covers all the sidewalk. It functions as the wastewater collection for all of the premises within the estate. In the estate, the factories were the first priority in the area, however, due to the closed lot with the only two streets connecting to Paholyothin Road, the government housing, residential development project, and industrial estate expansion has been developed using the same infrastructure. Since all the drainage water in the estate as directed to the only two exits with limited capacity, the drainage water became overflow. In addition, there was no maintenance schedule, and based on the survey condition, the drainage was blocked, broken, or full of sediment stagnant inside the manhole.

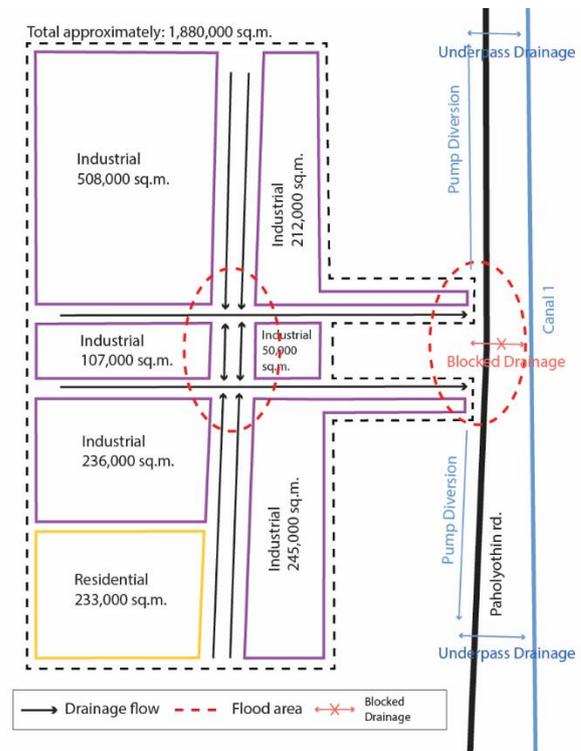
Fig. 7: Landuse, drainage and flood areas at Km. 44 Estate.

In addition, waste water from households also becomes an issue since stormwater and wastewater are combined. The universal drainage design is 60 - 80 and 100 cm diameter at maximum. Therefore, the drainage could be overloaded if many the households drain their wastewater at the same time, especially when the stormwater or wastewater drainage is following a set of standard regardless of the drainage network. The size of the estate, as shown in Fig.7, reflects that the size of the estate is quite large for the drainage outlet. In case of heavy rain, the water run-off would overflow the drainage.

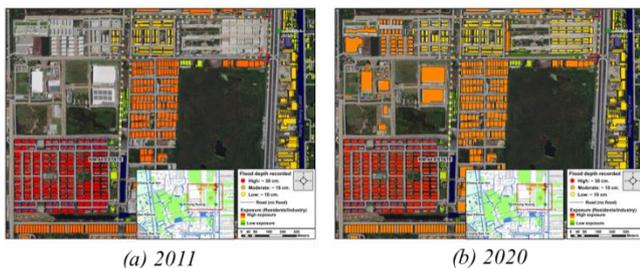
The exposure comparison between 2011 and 2020 has shown the transformation of natural and green areas in the western-northern and eastern-northern areas of the study area into the industrial and business areas respectively, and the exposure range is visualized on the basis of high building and building categories. Buildings in the Km.44 Estate are highly exposed due to the presence of 168 buildings, 7,560 units and approximately 15,120 persons, as shown in Fig. 8.

**Fig. 8: Exposure maps in 2011 and 2020.**

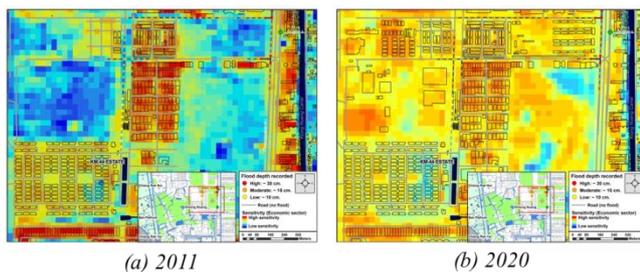
In 2011, industrial production was almost highly sensitive in the center and south of the study area, while it was in industrial zone. Subsequently, the high sensitivity area in 2020 is transformed into an increased industrial and commercial area in the north and west of the study areas, and natural green area in east as well as shown in Fig. 9.

**Fig. 9: Sensitivity maps in 2011 and 2020.**

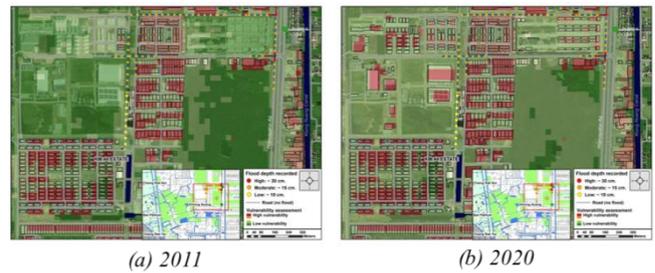
Almost residential and industrial zones are the most vulnerable to exposure and vulnerability in this study region (Fig.10) as these areas are linked to social life and the economic field. In addition, the high vulnerability identified in the eastern community as the nearby main road, Paholyothin Road and Klong 1, should perhaps concern social, economic and environmental impacts.

**Fig. 10: Vulnerability map in 2011 and 2020.**

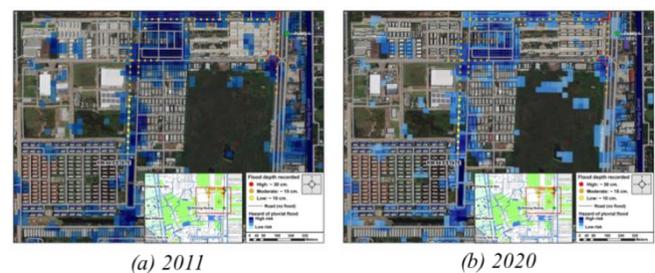
Pluvial flood hazards were found to be almost a road threat, especially in low elevation areas such as the northern part of this study both in 2011 and 2020, but in 2011 the hazard was higher than present caused by heavy storm and rain in 2011 (Fig.11). In addition, stormwater from Km.44 can be assumed to have been flooded on Paholyothin Road’s drainage. As a consequence, it affects traffic on the major road when heavy rains occur. As a result, vehicles passing along road are affected as a whole.

**Fig. 11: Pluvial flood hazard maps in 2011 and 2020**

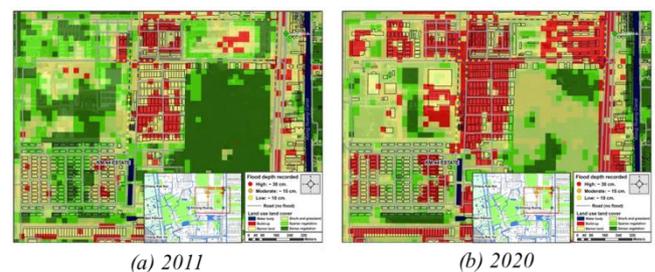
However, the relative difference in the estimation of adaptive capacity using NDVI data without a drainage system. The high ability to reduce the risk of pluvial flooding is linked to green and wetland areas such as the western and eastern areas. Analysis of these natural adaptive capacities has shown that these areas have been changed to bare land more from 2011 to 2020, as seen in Fig. 12.

**Fig. 12: Adaptive capacity maps in 2011 and 2020.**

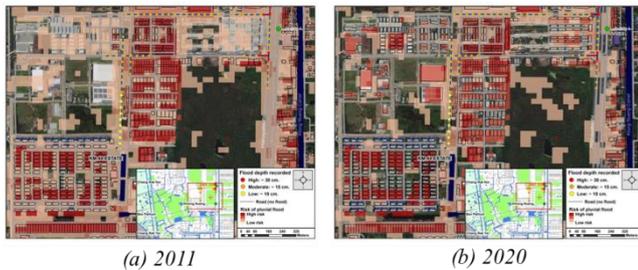
Finally, the potential risk of pluvial floods in this study area is increasing due to vulnerability of exposure and sensitivity increased, while the adaptive capacity factor is decreased. As a result, pluvial flood risk trend is the largest

increase in residential, industrial, low elevation, built-up and bare land areas, such as west and east of study area as shown in Fig. 13.

Fig. 13: Pluvial flood risk maps in 2011 and 2020.
