The Electricity Systems Inspection Case Study for Electrical Substations in Thailand

Surin Charoenchit^{1,*} and Chaiyapon Thongchaisuratkrul¹

ABSTRACT

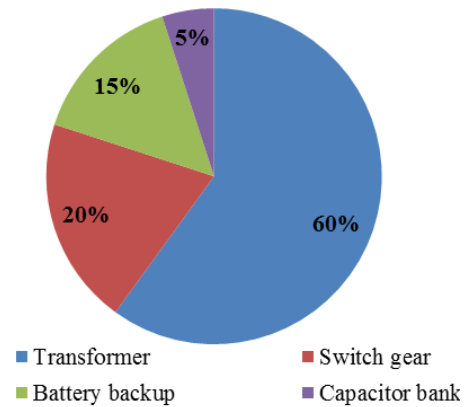
Fig. 5. Inspection of Overall Substations.

From the inspection of electrical substation in four stations, percent of damages and deteriorations are shown in Fig. 5 which it considers only number found deterioration. Overview, the most damage or deterioration is in transformers approximately 60%. The next deterioration occurs in switch gear about 20%. The third deterioration is battery backup at 15% and the final found deterioration is in capacitor bank about 5%.

In this research, the systems consist of AIS and GIS substations therefore transformers are installed both of outdoor and indoor places. The majority of deterioration occurs in the AIS substation which their transformers place outdoor. The devices are affected by environment; solar, rain, wind storm and so on. Therefore, devices are risk to deteriorate. Transformer should always be checked and done maintenance to prevent probably damage. The cost of transformer is expensive while maintenance cost is much cheaper than a new transformer replacing cost. The second equipment deteriorations are in switch gear. Switch gear

consists of the main open/close circuit devices. The devices are move to close or open circuit so it probably sparks and arcs occurred. Therefore, arc quenching and movement devices always deteriorate. On the other hand, both battery and capacitor are two last deteriorations. Mostly, they are damage by lift time. Therefore the system should focus carefully the first is transformer and the next are switch gear, battery backup and capacitor bank.

1. Considering the risks and equipment deterioration in electrical substations from four substations with routine maintenance, the research reveals that the most occurs in transformer at 60%. The second is in switch gear approximately 20%. The next is battery backup at 15% and the final is capacitor bank at 5%.

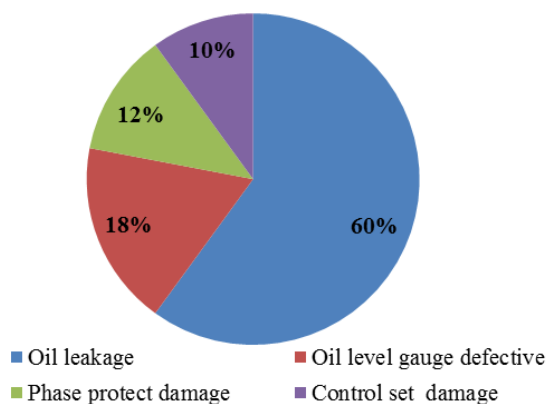
Fig. 6. Inspection of Transformers.

As the inspection of four electrical substations, although, the substations are performed monthly and yearly routine maintenance, it is still found that there are deteriorations occurred in transformers. There are four deteriorations as shown in Fig. 6. The results show that deteriorations consist of oil leakage, oil level gauge defective, phase protects damage, and control set damage. The most problem and deterioration is oil leakage about 60%. The second deterioration is oil level gauge defective approximately 18%. The next two problems are phase protection damage and control set damage at about 12% and 10% respectively. Some deterioration in transformers are shown in Fig. 7. For problem of oil leakage, the oil in transformer is used as insulator and heat transfer. The problem of oil leakage is caused by rubber seal deterioration. Transformer which have high electrical load period, the heat is also high. Then, oil is hot especially if the electrical load over 80% of rate. The rubber seal of transformer, which sinks below hot oil in the long time, is probably deteriorated before suitable life time. Therefore, the load of transformer should not more than 80% of rate. If oil leakage occurs, it effects on heat transfer. The transformer is higher up rapidly probably over heat and defective. Therefore, it should be done maintenance immediately.

Because cost of new transformer is large more expensive than maintenance cost, the problem should be solved instantaneously. In the case of oil level gauge defective, generally the gauge is defective by life time. The

gauge is important for routine checking. It should be calibrated for measuring precisely. If this gauge defective, the value of oil level is not the right check. Therefore the oil may be leakage, and then the insulation and heat transfer are not enough. This case probably breakdown and over heat in transformer. In the case of phase protection and control set damage is found the less. However, it is the most important because it protects the loss and damage in the case of emergency or accident. If the protection and control is not run in the case of faults, not only transformer is damaged but other equipment also.

2. The most risks and equipment deteriorations which found in transformer with routine maintenance is oil leakage about 60%. The second is oil level gauge defective approximately 18%. The next equipment deterioration is phase protect damage about 12% and finally, control set damage is the last at about 10%.

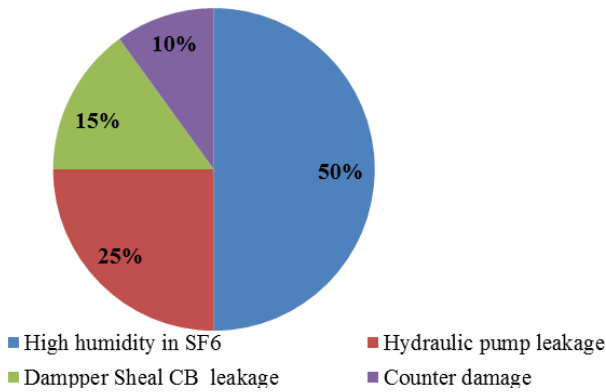
Fig. 8. Inspection of Switch Gear.

In this section the deteriorations in switch gear of four electrical substations are inspected. Although they are done routine maintenance, they are still found deteriorations including high humidity in SF₆, hydraulic pump leakage, damper seal CB leakage and finally counter damage. The inspection of four electrical substations in switch gear is shown in Fig. 8. It is found that the most found deterioration switch gears are high humidity of SF₆ about 50%. The second deterioration is hydraulic pump leakage at about 25%. The next is CB damper seal leakage approximately 15%. Finally, counter damage is the last about 10%. By the way SF₆ insulation gas, it is used to quench the arc in circuit breaker of switch gear. If the gas is high humidity, the SF₆ gas insulator is low characteristic of insulation and arc quenching. Therefore, in the case of open or close circuit by breaker, the arc occur high harsh arc. These effects on the fire or blast in switch gear. This brings the breakdown in system and damage in equipment. Moreover this probably brings blackout around the area. For hydraulic pump, it is used to be force for drive breaker

open/close circuit. The force is occurred by oil pressure. Therefore, in the case of leakage, the force is less depending on the oil, then it cannot drive breaker. This is problem because the electrical system is not close and open anytime it needed. It should be changed immediately. For CB (Circuit Breaker) damper leakage, it occurs from oil is leakage so the pressure to force breaker close/open is less. While the force of hydraulic sends to breaker, the leakage CB damper is not send the force to close or open circuit. The CB is harsh vibrated. This CB is damaged. The hydraulic and CB damper leakage are shown in Fig. 9. In the case of counter, it is used to count the number of close and open circuit breaker. Generally, the breaker should not often open and close because the arc would damage it. So, the number of close and open is limited for maintenance. If the counter damage, it is not sure the time to maintenance.

3. The most risks and equipment deteriorations which found in switch gear with routine maintenance is high humidity in SF₆ at 50%. The second deterioration is hydraulic pump leakage approximately 25%. The next is CB damper seal leakage about 15%. The final deterioration is counter damage about 10%.

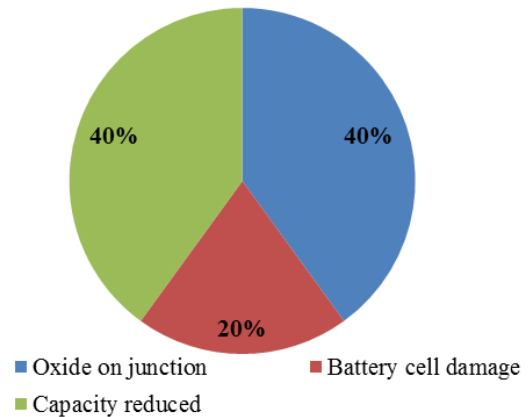
Fig. 10. Inspection of Battery Backup.

In this section the deteriorations in battery backup of four electrical substations are inspected. Although they are done routine maintenance, they are still found deteriorations including oxide on junction, battery cell damage and finally capacity reduced. The inspection of four electrical substations in battery backup is shown in Fig. 10. It is found that the most deteriorations or risk are two behaviors including oxide on junction and battery capacity reduced at the same about 40%. Finally, one is battery cell damage at about 20%. The battery in substation is used to energy

storage in the case of power outages. The conserved energy is important on stability of system especially emergency case. When they are not used in the long time, they may be neglected to maintenance. From inspection, it found that the oxide occur on terminal as shown in Fig. 11. This problem causes on the efficiency directly of battery. The oxide effect on conductance condition of connector is lower. So the current distribute is low also. If they are neglected, battery life time is shorter than it should be. They should be clean in routine. The capacity of battery reduces because of lake of maintenance and maybe it occurs by life time. Generally, battery life time is about 3-6 years. Battery should be not used still loss out energy storage. This causes on life time also. The terminals of battery are cleaned in the routine. The place of installation should be dry which avoid high humidity.

4. The most risks and equipment deteriorations which found in battery backup with routine maintenance are oxide on junction and battery capacity reduced at each of 40%.

The final is battery cell damage at 20%.

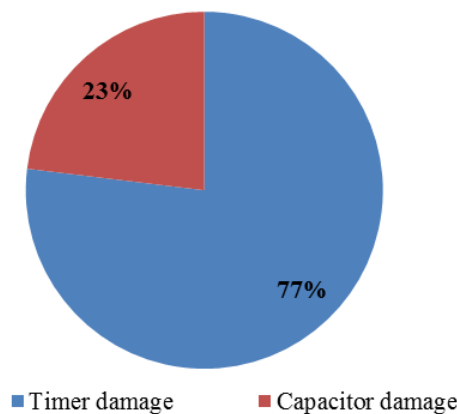
Fig. 12. Inspection of Capacitor Bank.

Although they are done routine maintenance, the deteriorations in capacitor bank are still found as shown in Fig. 12. It consists of timer damage and capacitor damage at about 77% and 23% respectively. The capacitor bank uses to improve power quality. The line is inductance and resistance load so the electricity occur drop voltage in the long power transmission line. So capacitor bank help improve voltage level up. Moreover, it is still power factor

correction also. In the case of timer, it is installed to time checking of capacitor discharge when technician and engineer would to maintenance. Generally, capacitor still has electric charge although it is not connected the power line. If the people touch it without discharge, the large electric charge flow pass to the body which the people is dangerous probably die. So this timer is very important for maintenance. It helps tell the suitable time to start maintenance. In the case of capacitor damage, it should be changed immediately. Because this problem effects on power quality of system for example the voltage drop at the end line which lower than the required load. And the power factor of system is low also which it effect on the loss is high.

5. The most risks and equipment deteriorations which found in capacitor bank with routine maintenance is timer damage at about 77%. The rest one is capacitor damage approximately 23%.
